Masonry and Glazing Repairs

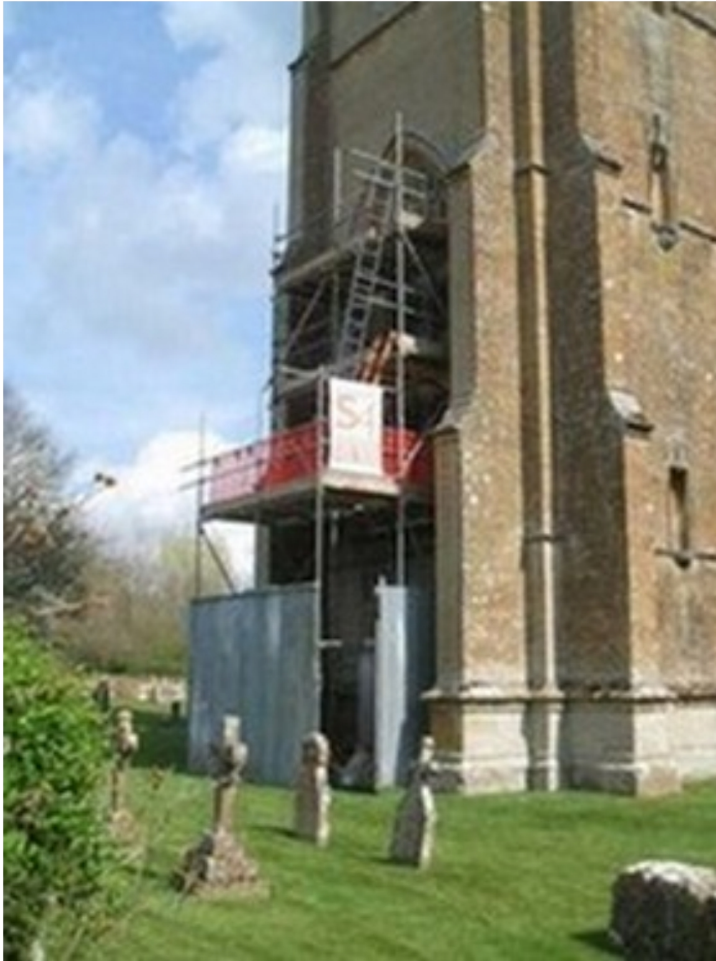
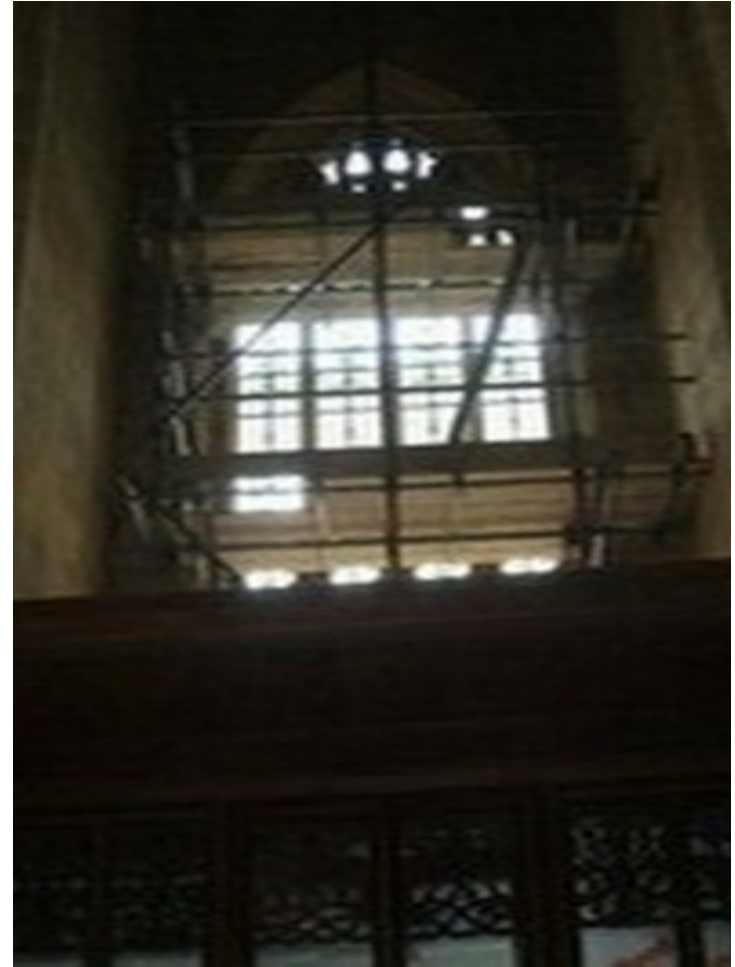
Lower half of the window - two mullions replaced and the
glazing completely dismantled and re-built using new lead
framework: with general masonry repairs to the upper half
– cost £20,000

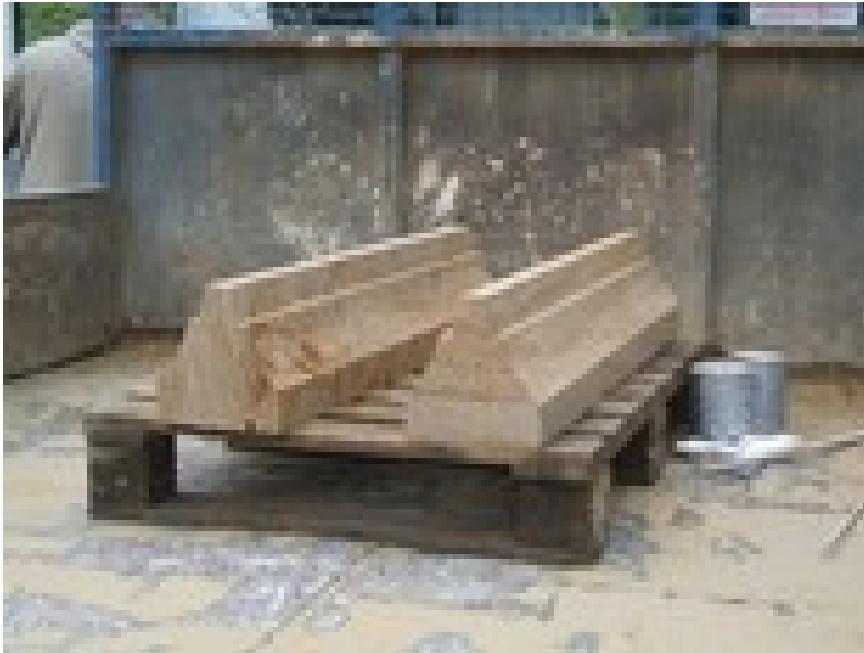
**Specially carved mullions
for the west window**

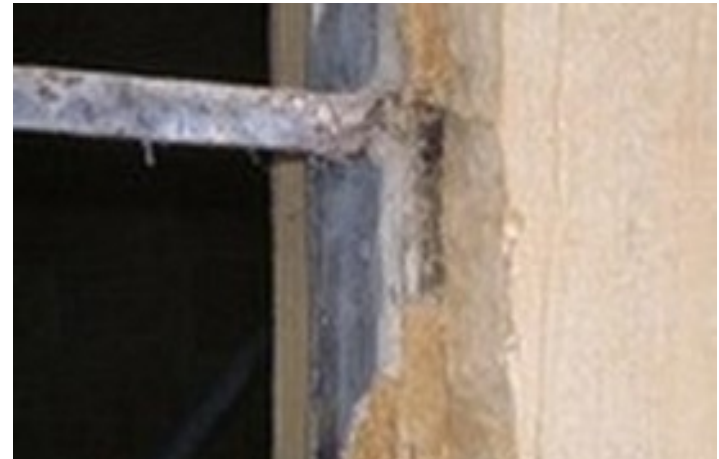
**Corrosion of 16 windows' iron
supports which expand to break
surrounding masonry**

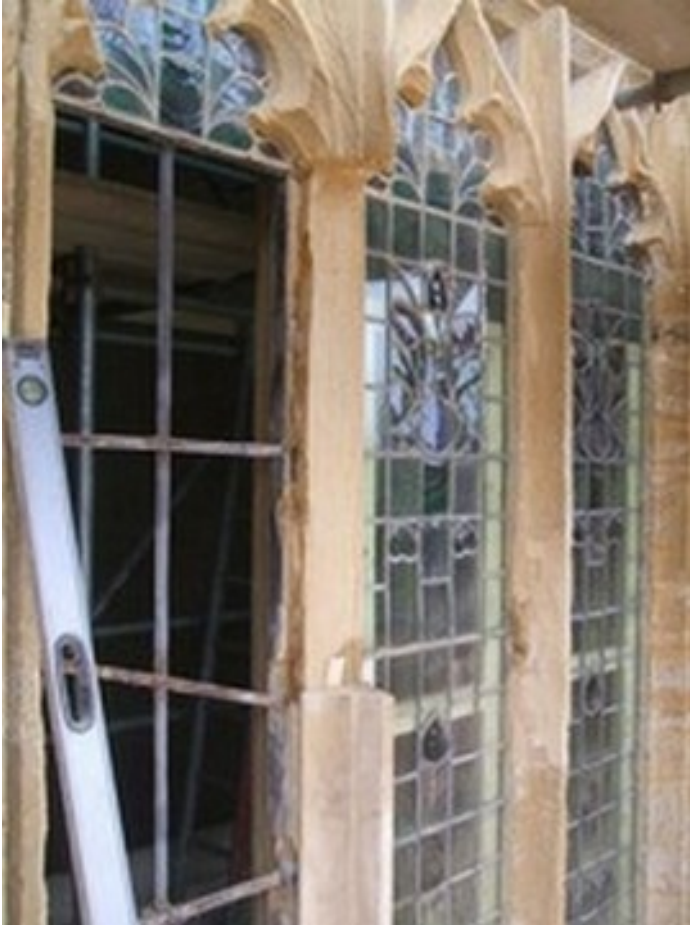
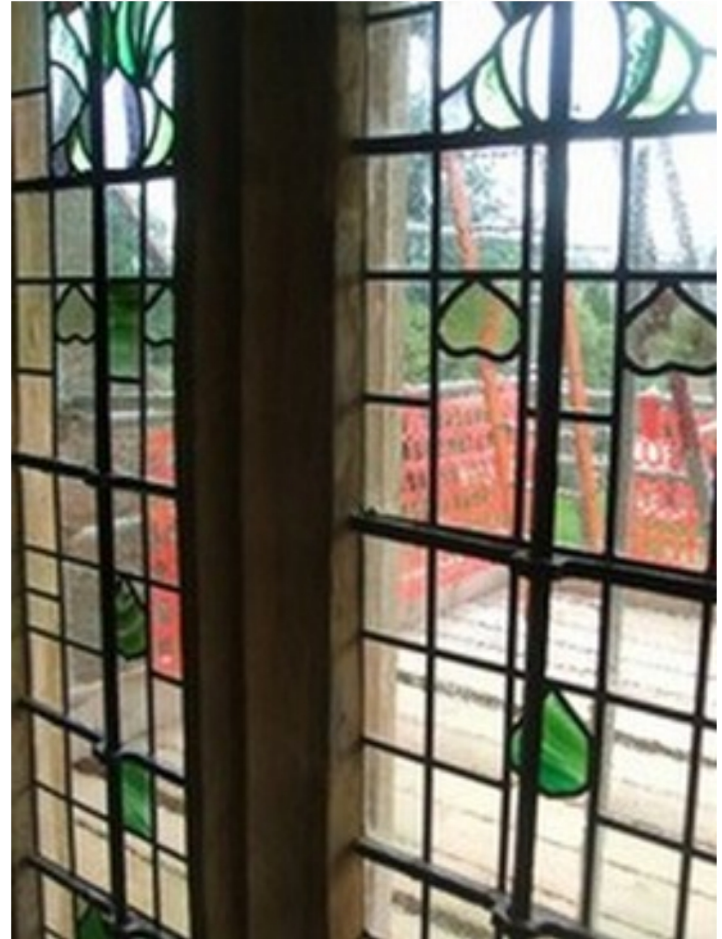
Masonry and Glazing Repairs to the west window

All the glazing of the lower windows had to be dismantled and then re-assembled with new lead flashing

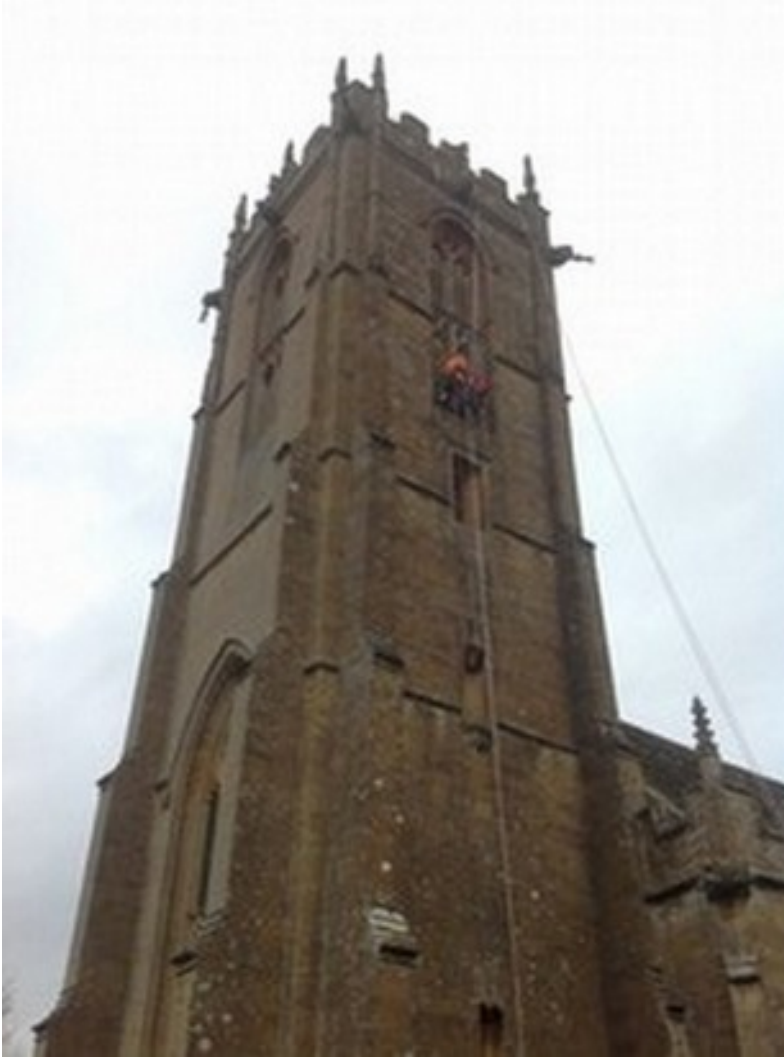
External upper tower work
achieved by abseilers

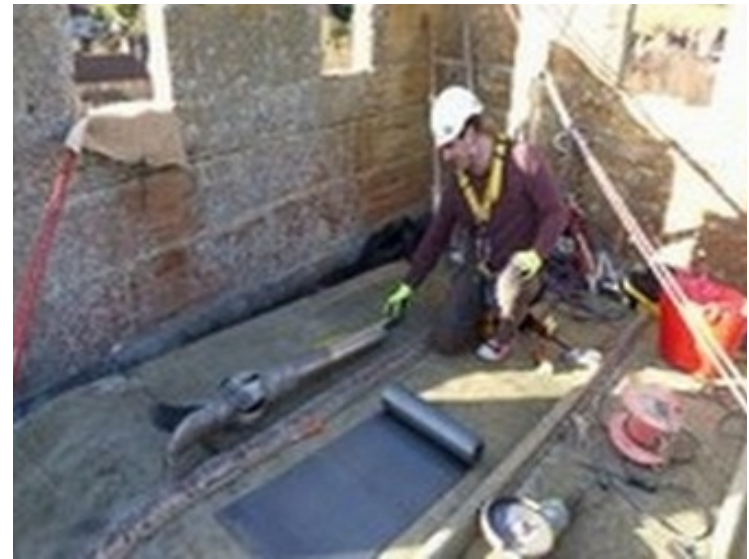
Abseiling, instead of
scaffolding, saved over
£8,000

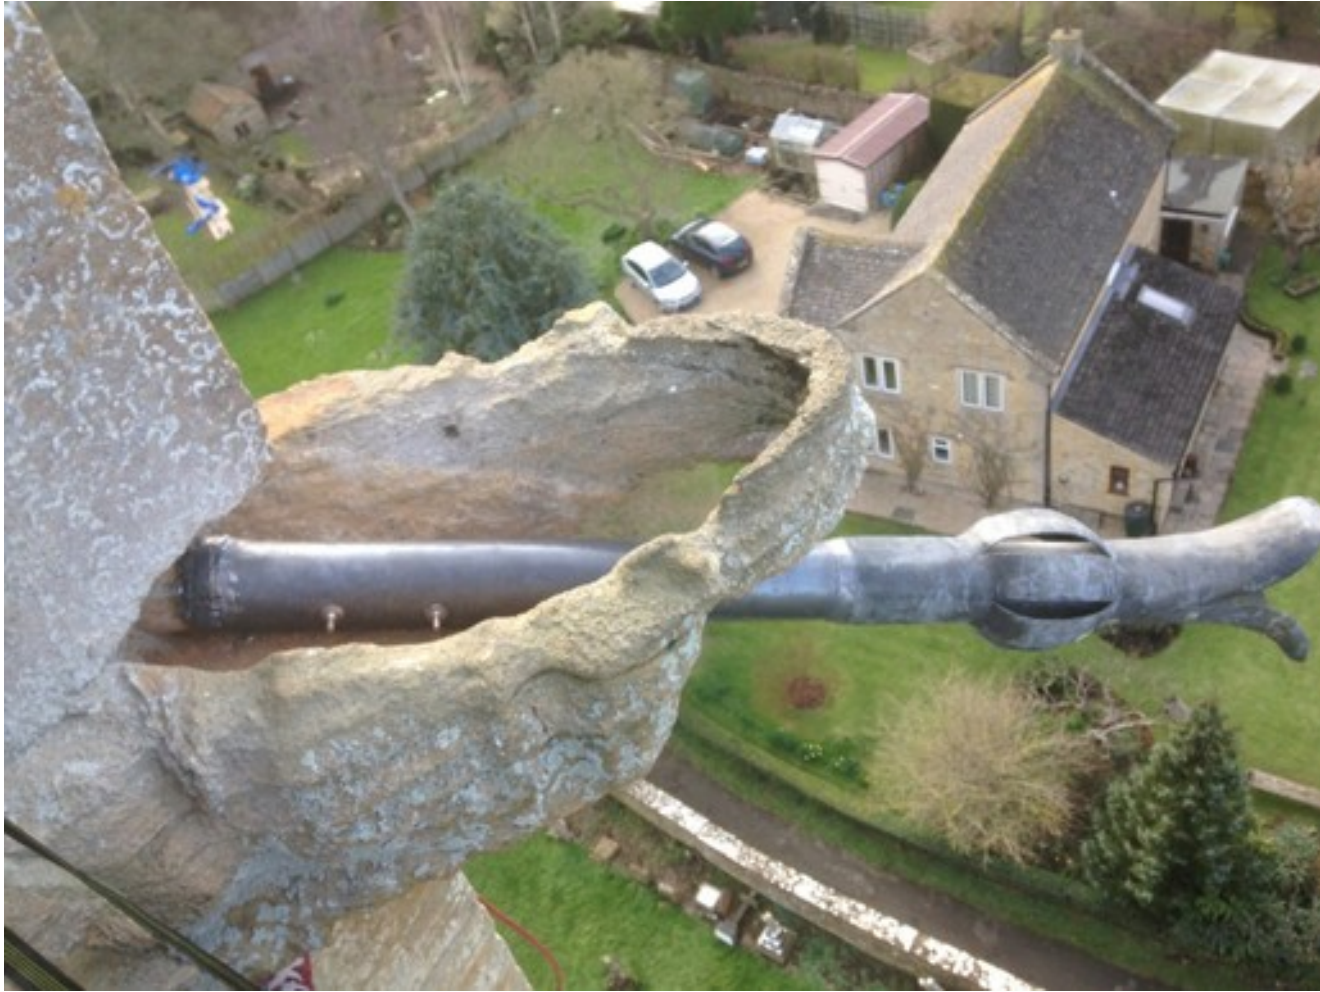
Major rebuild of four tower water shutes

Crumbling of supporting gargoyles caused breakages of water shutes

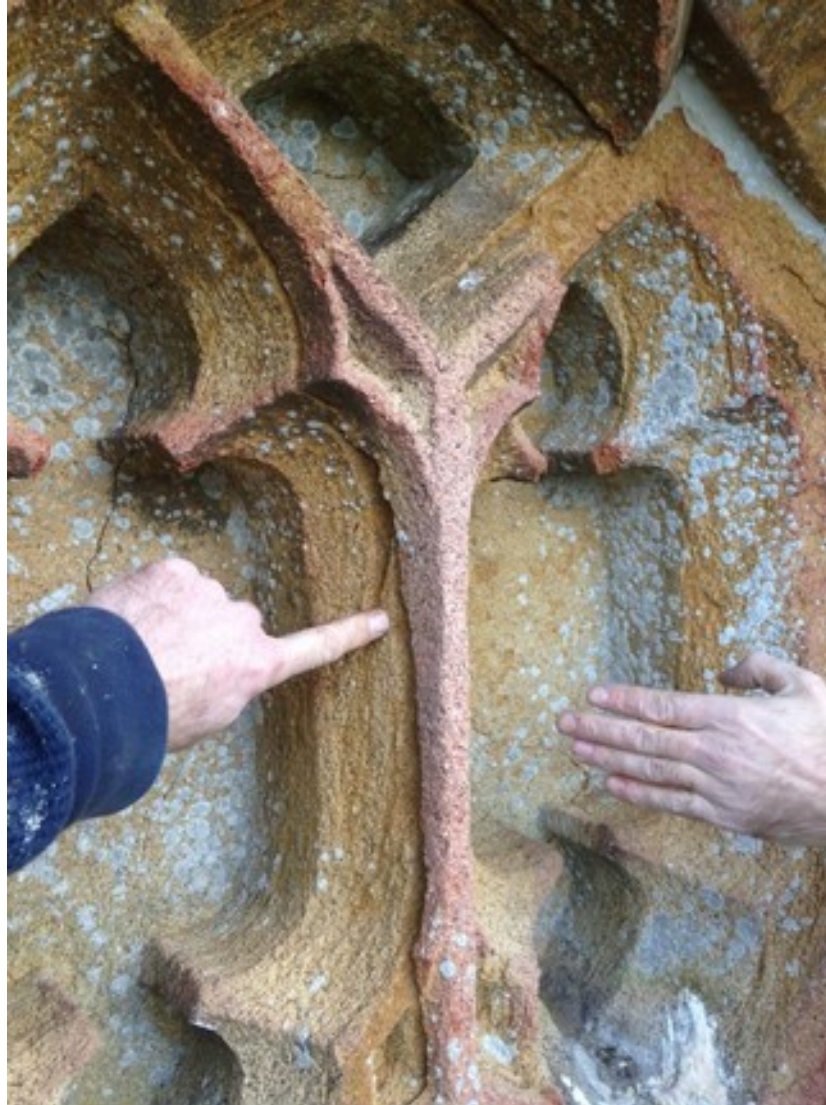
**Cracks in sound louvre masonry on all
four sides of the tower**

**The costs of these masonry repairs were paid for
by the Norton Church Bells ringers**

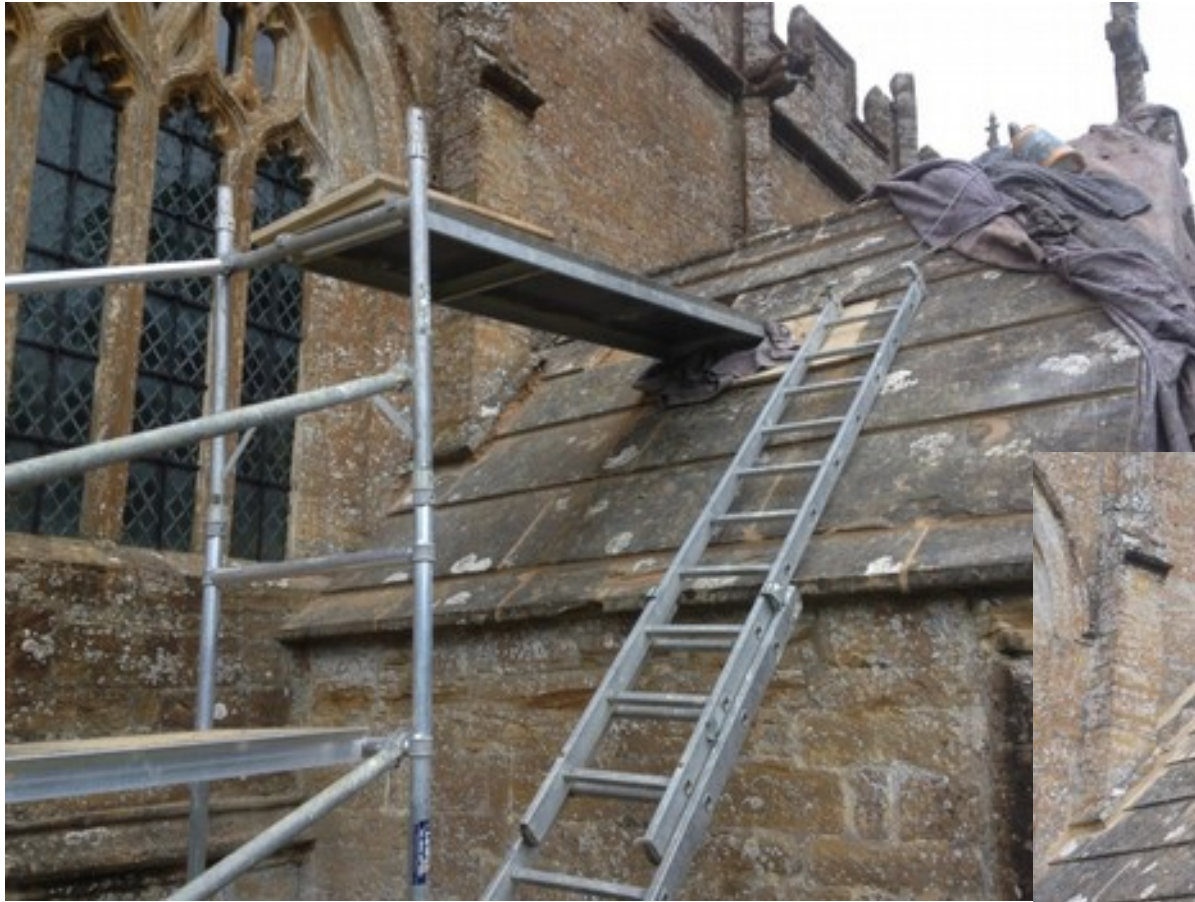
**Mortar Repairs to the south porch roof
with two newly carved stone tiles**

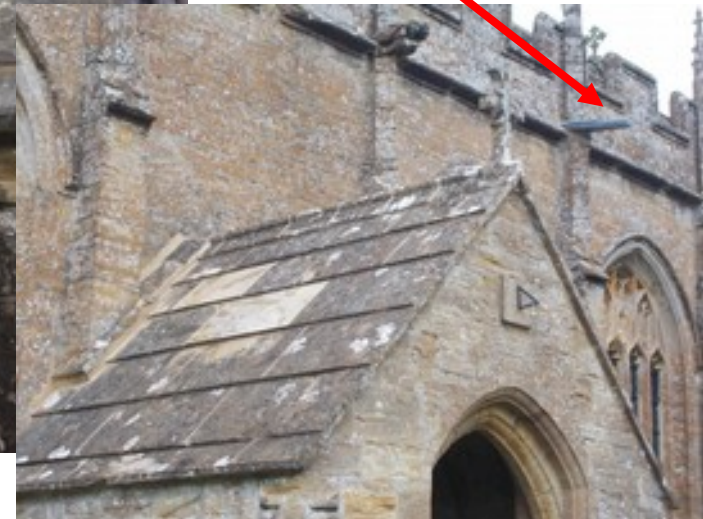
**New rainwater
chutes on south and
north aisle gutters**

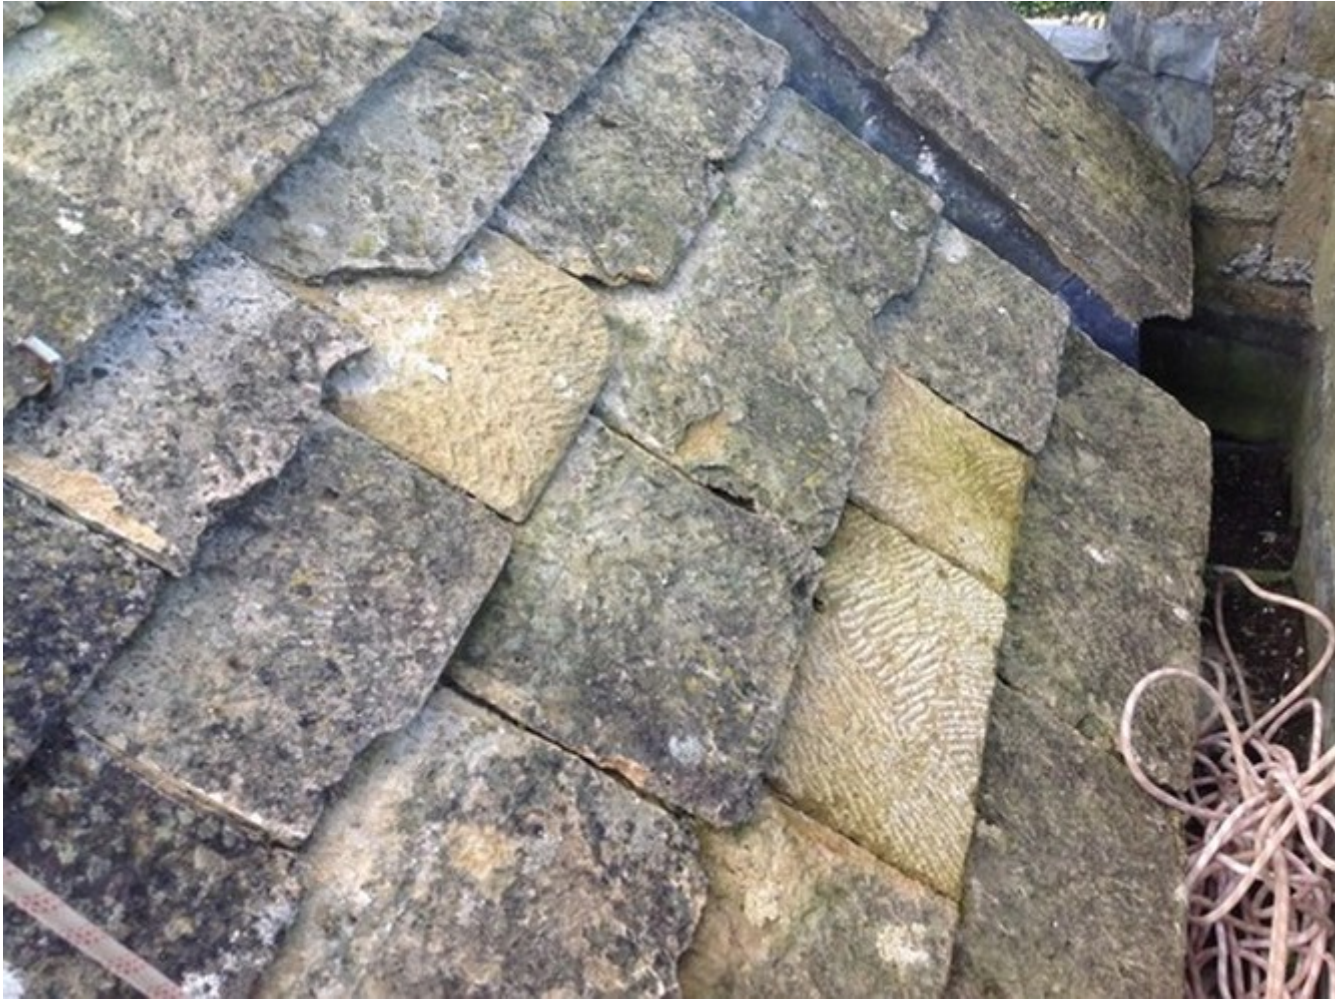
Specially carved new tiles for north aisle roof

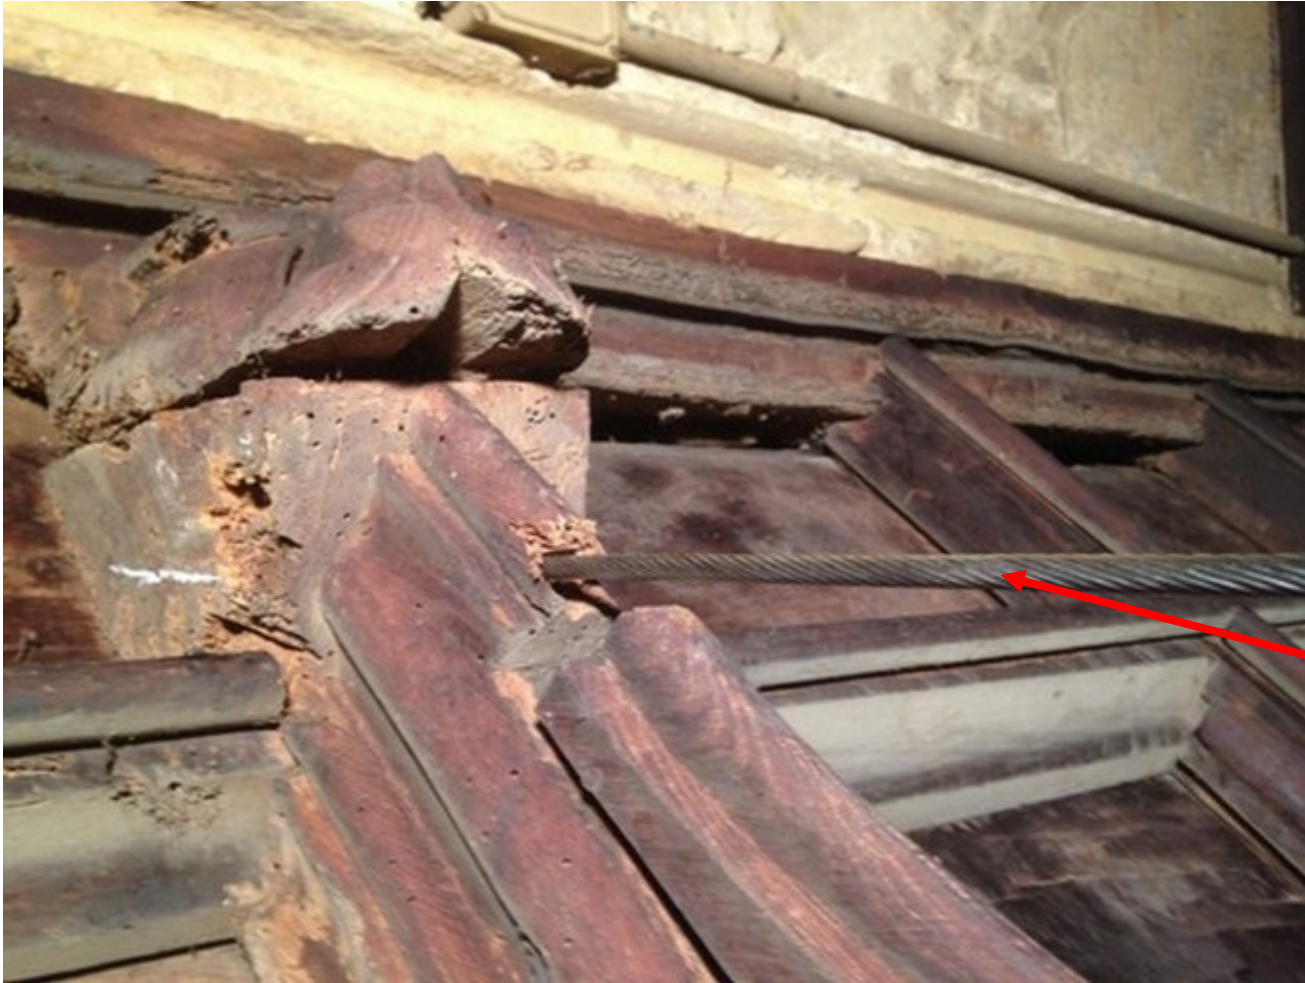
**Densher Structural Engineer
designed the repair**

**Steel cable for
additional
strength**

**Rainwater running down tower wall
caused wet rot in roof timbers**

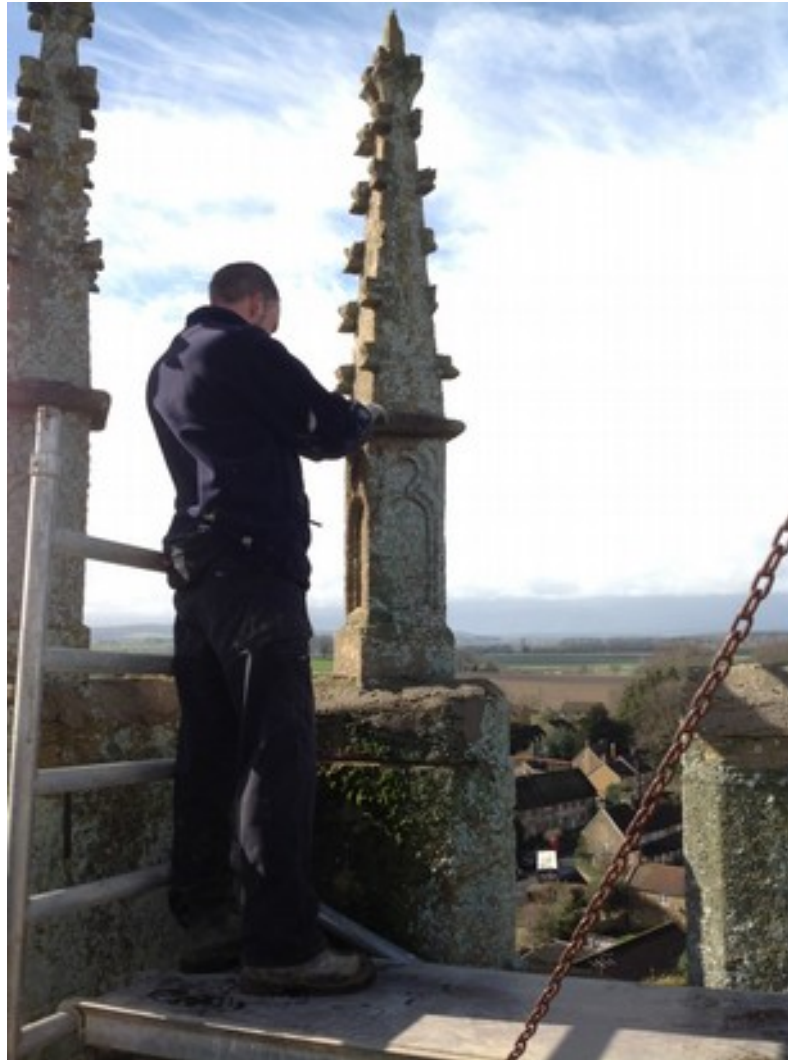
After a tower pinnacle fell to the ground during a storm, these two pinnacles had to be strengthened

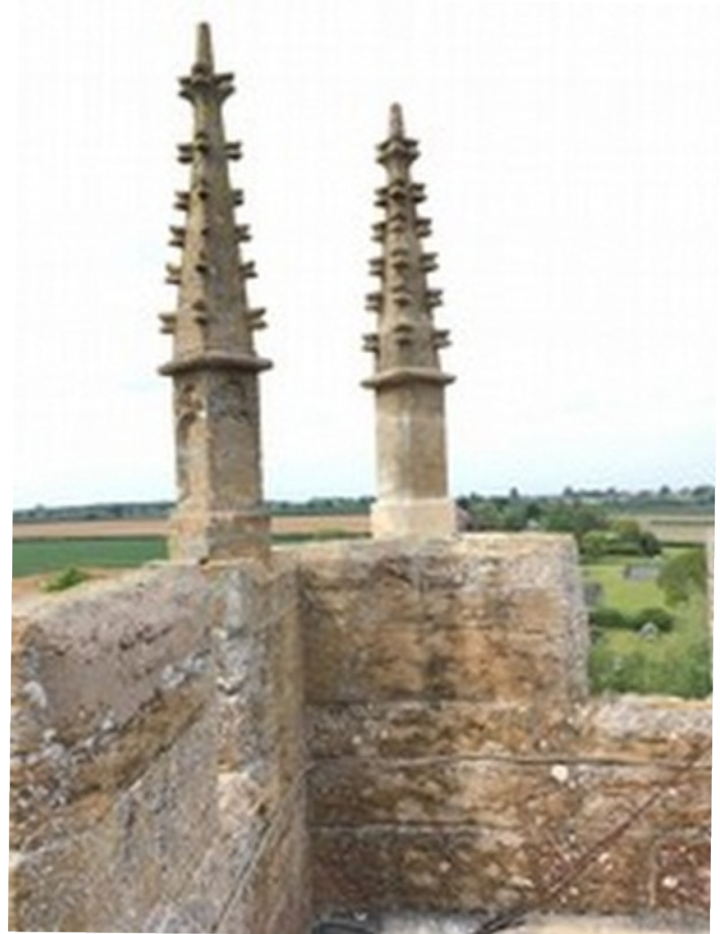
Pinnacle base seriously eroded

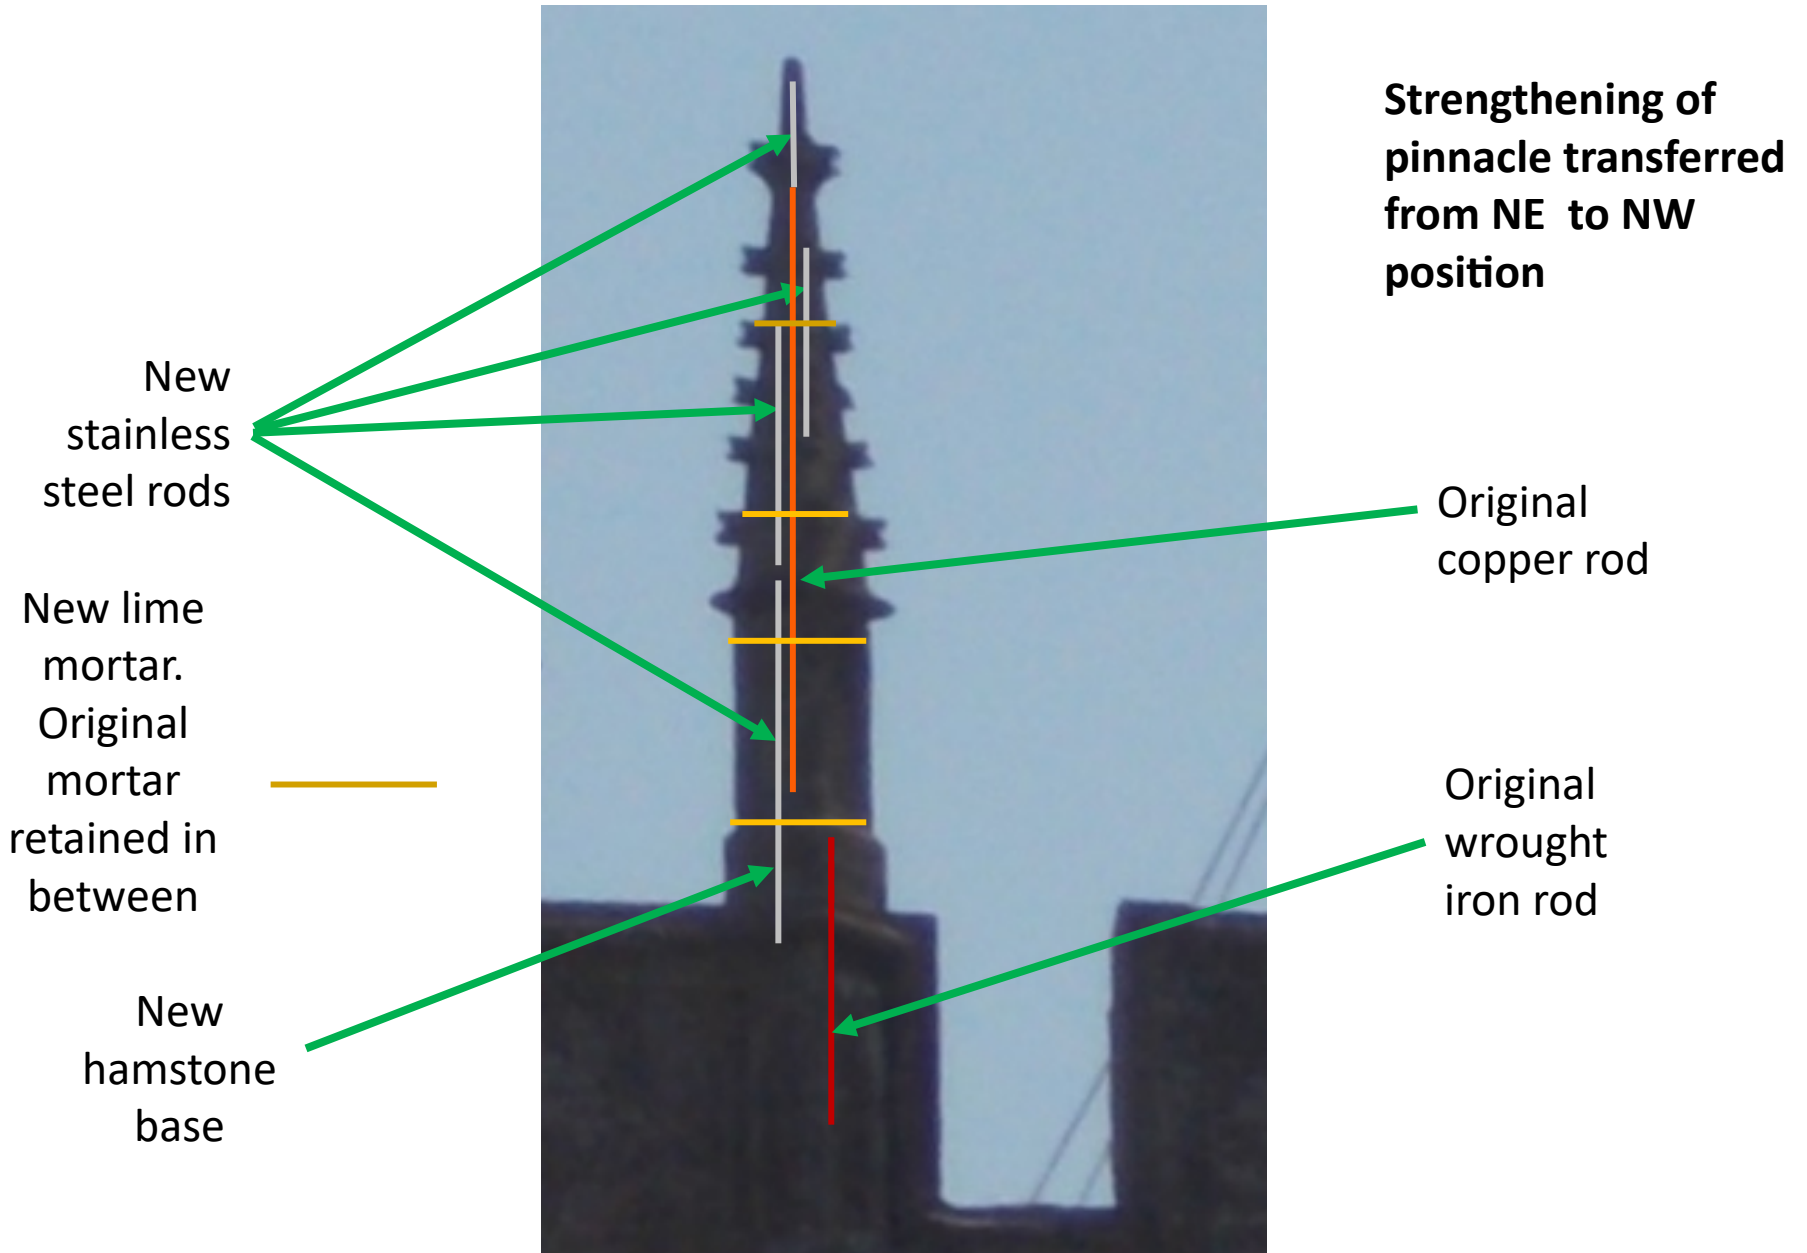
**All three upper tower corners,
which can be viewed from the
roads, now have two pinnacles**

**Strengthening of
pinnacle transferred
from NE to NW
position**

New
stainless
steel rods

New lime
mortar.
Original
mortar
retained in
between

New
hamstone
base

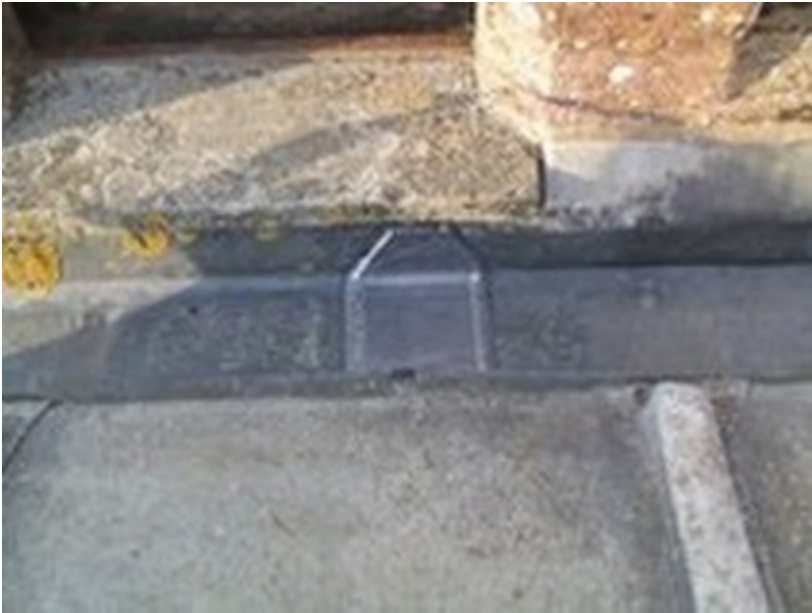
Rain water was observed running down inside of tower wall

Lead work by Renny Shepherd

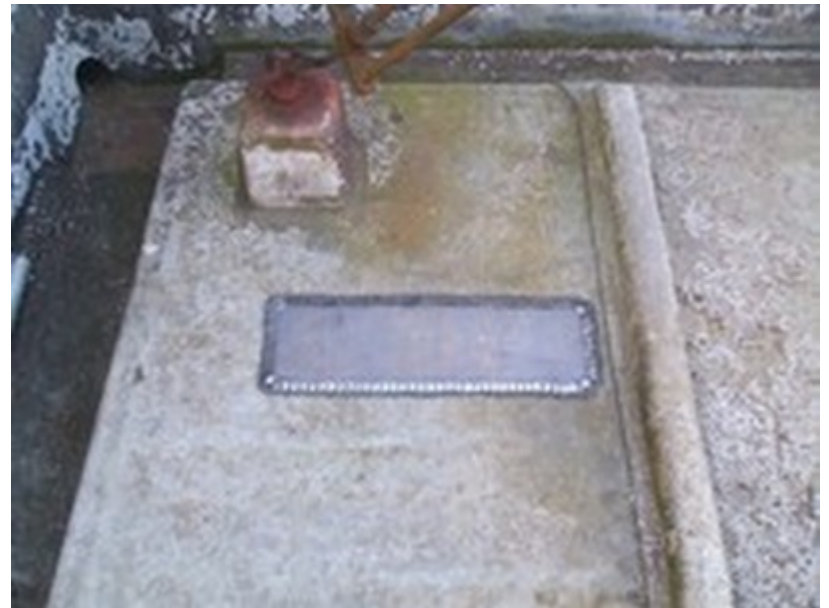
Repairs to lead on tower roof

Delay would have caused catastrophic rotting of roof timbers
